Manhole Inspection Summary

Manhole # S65I__008MH

Insp Date: **6/3/08 11:13 AM**

Location Address: **6000 Eastern Ave.**

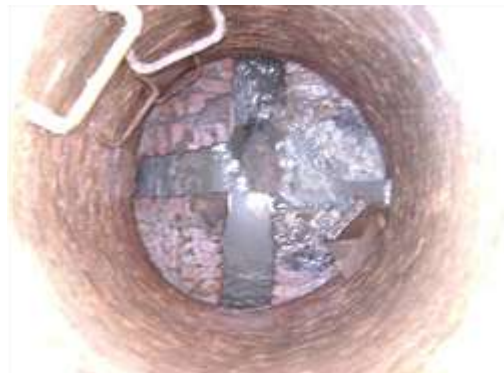
Top View

Broken manhole cover sitting on bench

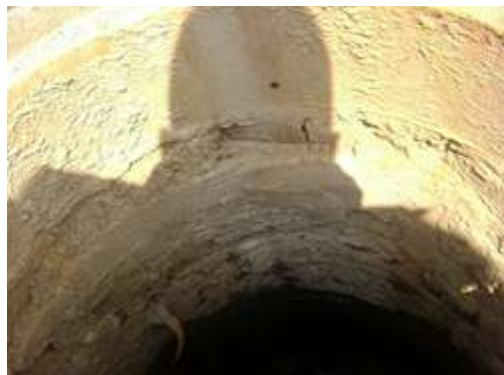
Defect 1

Offset: **2** (in.)

Condition: ☐ Sound ☒ **Cracked** ☐ Leaks

frame offset

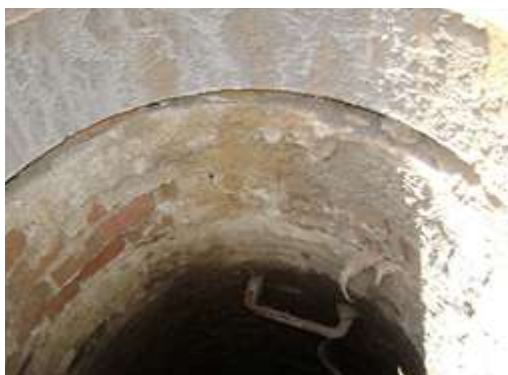
Defect 2

Condition: ☐ Sound ☐ Cracked ☐ Root Intrusion ☒ **Loose Brick** ☒ **Deteriorated**

Infiltration: ☐ None ☒ **Joint** ☐ Cracks ☒ **Mortar** ☐ Roots ☐ Wall

gap under frame at frame adjustment area.

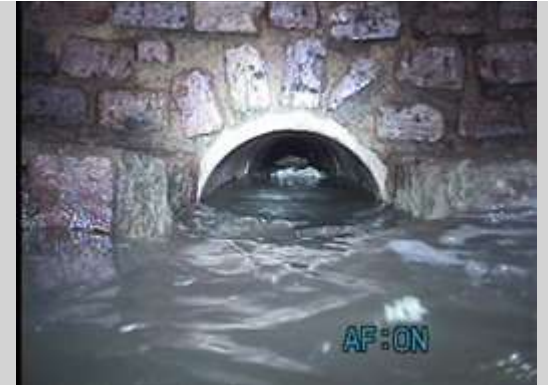
12 O'Clock Outflow

10 in. Circular Gravity Sewer
Pipe Out @ 12 O'Clock

Pipe Height: **9.6** (in.) Rod and Bar (Angled)
Pipe Material: **Clay** ☐ Pipe Lined
Invert Depth: **10.00** (ft.) Flow Characteristics: **Slow**
Deposits: ☐ None ☐ Mud ☐ Sludge ☒ **Debris** ☐ Grease
Silt Depth: **2** (in.) Deposits Extent: **Heavy**
Infiltration: **None** Pipe Seal Cond: **Sound**

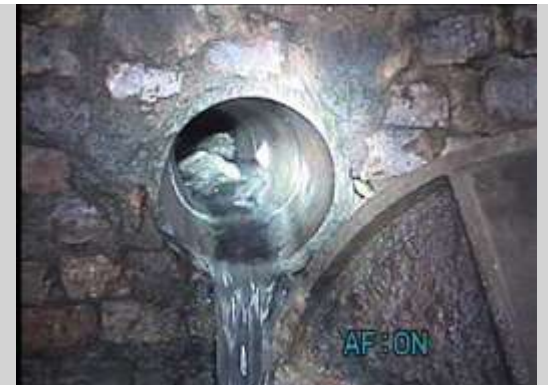
3 O'Clock Inflow

Comments **DROP LINE IS PARTIALLY CLOGGED.**

Drop In @ 3 O'Clock

Pipe Height: **8.4** (in.) Rod and Bar (Angled)
Pipe Material: **Clay** ☐ Pipe Lined
Invert Depth: **8.33** (ft.) Flow Characteristics: **Slow**
Deposits: ☐ None ☐ Mud ☐ Sludge ☒ **Debris** ☐ Grease
Silt Depth: **2** (in.) Deposits Extent: **Medium**
Infiltration: **None** Pipe Seal Cond: **Sound**

Drop: **Outside** Rod and Bar
Angled: **Yes** Reading: **8.83** (ft.)
Inv Depth: **9.83** (ft.)
Drop Condition: **Partly Clogged**

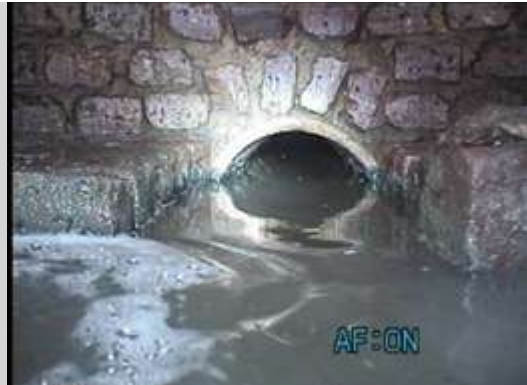
6 O'Clock Inflow

Pipe In @ 6 O'Clock

Deposits: ☐ None ☐ Mud ☐ Sludge ☒ **Debris** ☐ Grease

Silt Depth: **2** (in.) Deposits Extent: **Medium**

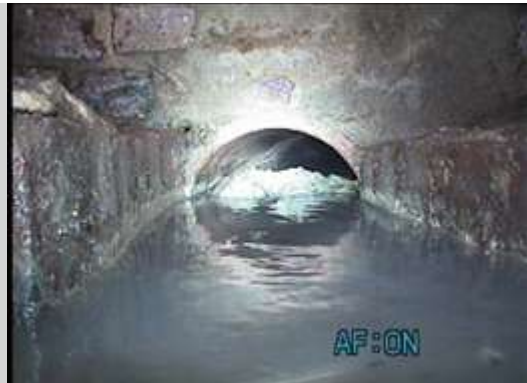
9 O'Clock Inflow

Pipe In @ 9 O'Clock

Deposits: ☐ None ☐ Mud ☐ Sludge ☒ **Debris** ☐ Grease

Silt Depth: **3** (in.) Deposits Extent: **Medium**
